Annual Inspection

Mid Suffolk District Council

Redlingfield Play Area

Inspection Ref: 1169217

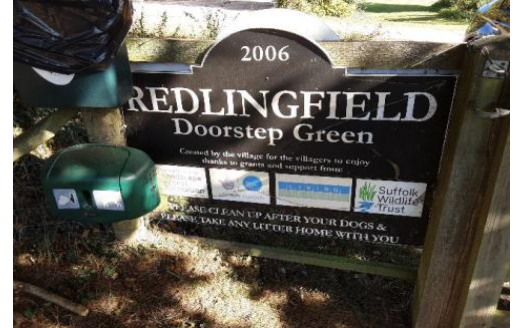
BS EN 1176 Part 7 recommends that signage shall include emergency contact details and contact details of owner / operator for reporting maintenance issues - Provide additional information

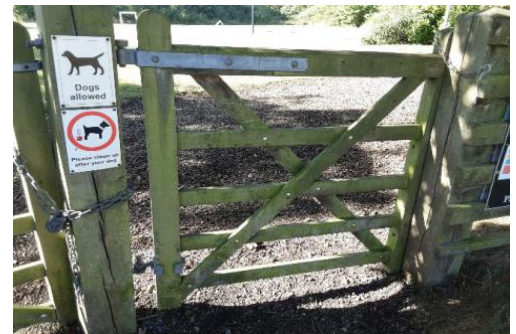
There are openings that are less than 12mm that could trap or crush fingers - Where possible a 12mm gap should be maintained on both sides or between the gate leaves

There are areas or parts of the timber hanging and slamming posts that have rotted - Replace all affected timbers

The gate is snagging on the surrounding surface preventing it from closing correctly - Carry out remedial works to ensure the gate closes correctly

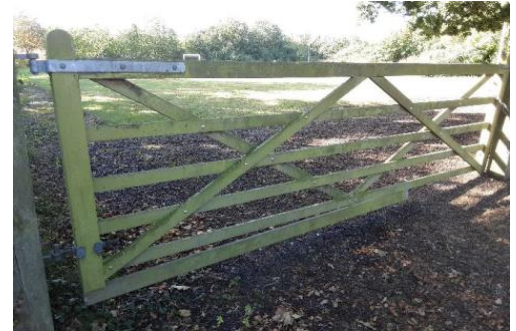
There are areas or parts of the timber hanging and slamming that have rotted - Replace all affected timbers

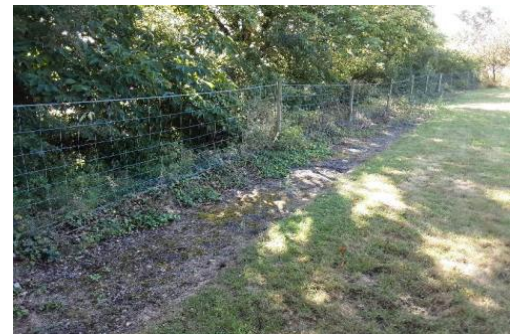
There are a number of loose posts around the fence - Reset as required

There are areas or parts of the timber on the structure that have rotted - Replace all affected timbers

The fence is damaged in places - Repair or replace all affected sections

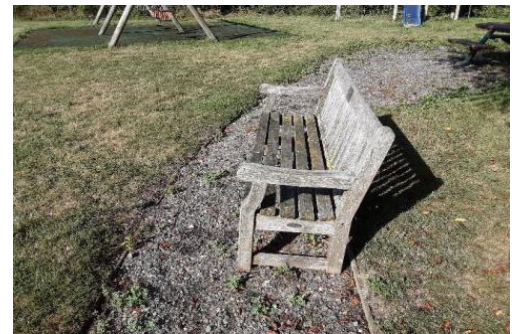
The bench is not securely fixed to the surface and there is some possibility of the item tipping or rolling over - Secure the bench to the ground

There is algae or moss on the bench - Clean and treat appropriately

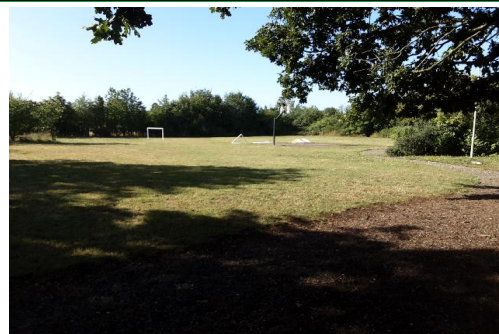
There are loose/damaged items in the play area - Remove the loose/damaged items

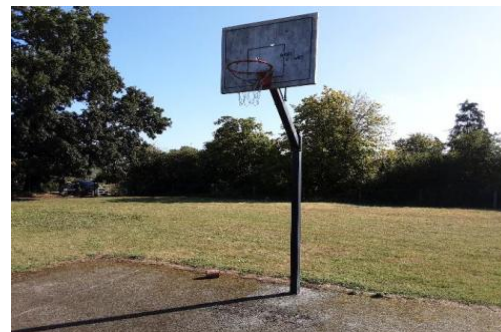
There is algae or moss growth on the tarmac surface resulting in slippery conditions - Clean and treat appropriately

The backboard is damaged - Monitor for any further deterioration and repair as required

There is algae or moss on the surface of the equipment - Clean and treat appropriately

A clearly visible facility sign should be provided in a prominent position with the wording as detailed BS EN 15312- the equipment is not intended for children less than 3 years old- the warning - Do not climb on the framework or nets- the warning - Do not hang on the ring (if provided)- the warning - Do not wear rings or other jewellery- name and telephone number of the administrator- number to call in case of accident - Monitor

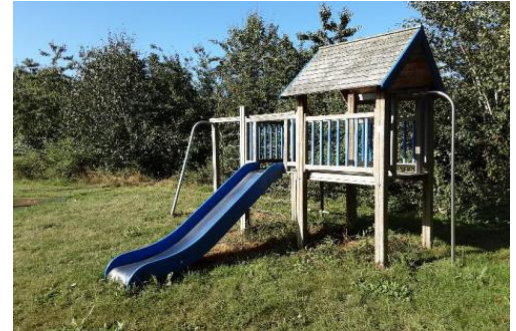
The hedge forms a hard object within the falling space of the equipment and there is also insufficient surfacing provided in contravention of BS EN 1176 Part 1 - Cut back the vegetation to provide a minimum of 1.50m unobstructed space

There is/are bolt cap covers missing or damaged on the item - Replace missing or damaged bolt cap covers

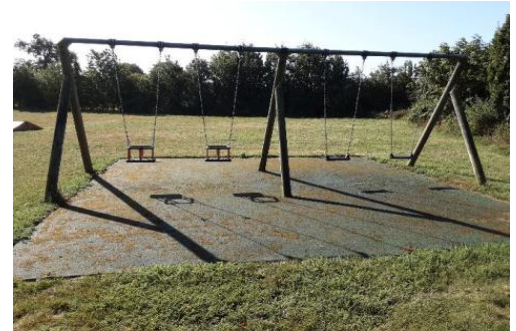
The surface is lifting at the edges and creating trip points - Repair perimeter of surfacing to remove trip points

There are significant gaps (over 30mm) between the surface and the edging or between the joints in the surface; these are large enough for a small foot to enter - Repair surfacing

The surfacing width under each seat is less than 1.75 metres and fails the requirements of BS EN 1176 Part 2 - Monitor - No remedial work recommended

There is algae or moss growth on the wet pour surface resulting in slippery conditions - Clean and treat appropriately

The bushes are showing signs of wear - Monitor for any further deterioration and replace as required

There is some strimmer / machinery damage apparent on the posts, this can penetrate the preservative applied to the timber and accelerate the rotting process - Monitor for any deterioration (rot) and replace as required

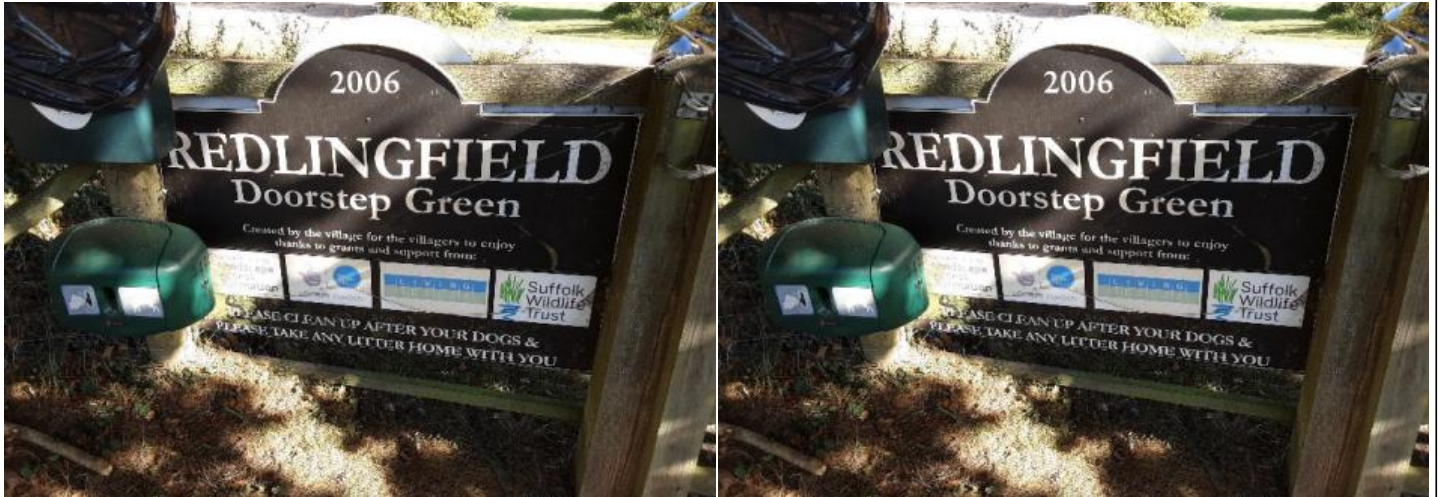
Finding: BS EN 1176 Part 7 recommends that signage shall include emergency contact details and contact details of owner / operator for reporting maintenance issues
Action: Provide additional information

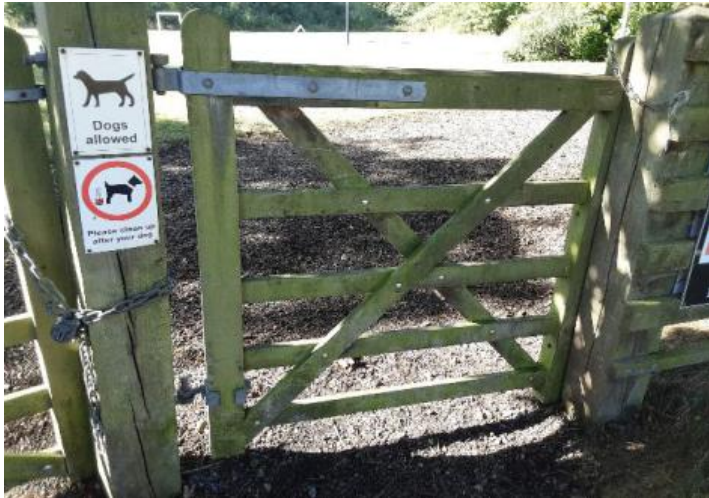
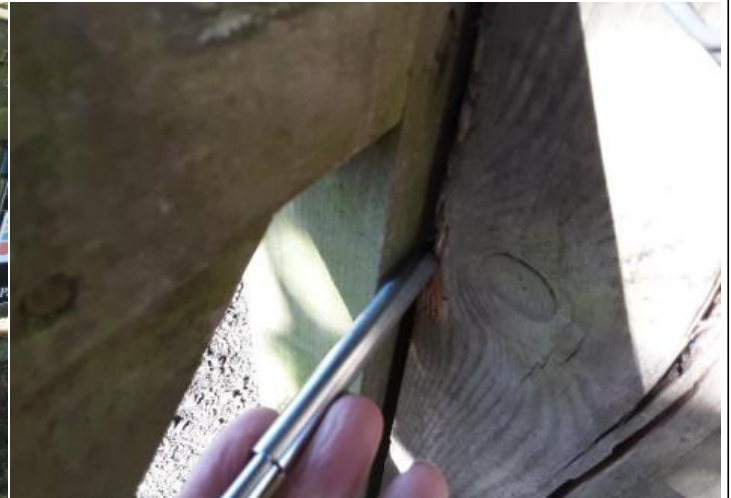
Finding: There are openings that are less than 12mm that could trap or crush fingers

Action: Where possible a 12mm gap should be maintained on both sides or between the gate leafs

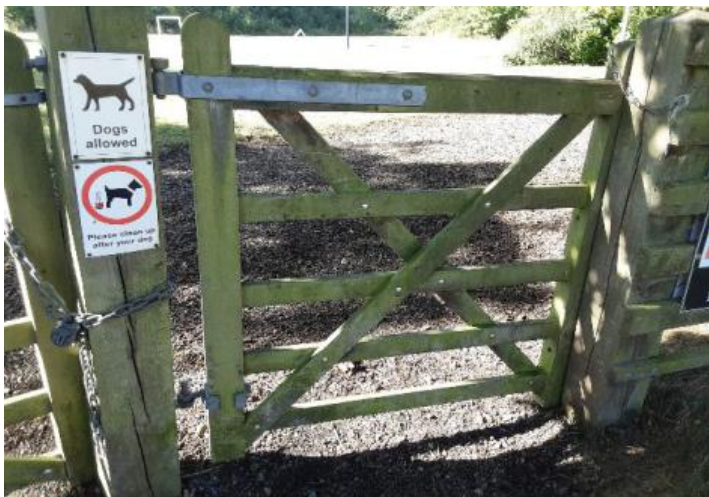
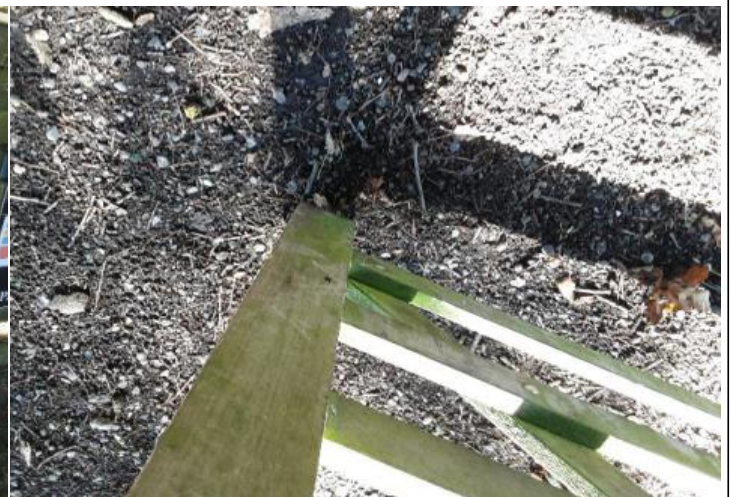
Finding: The gate is snagging on the surrounding surface preventing it from closing correctly

Action: Carry out remedial works to ensure the gate closes correctly

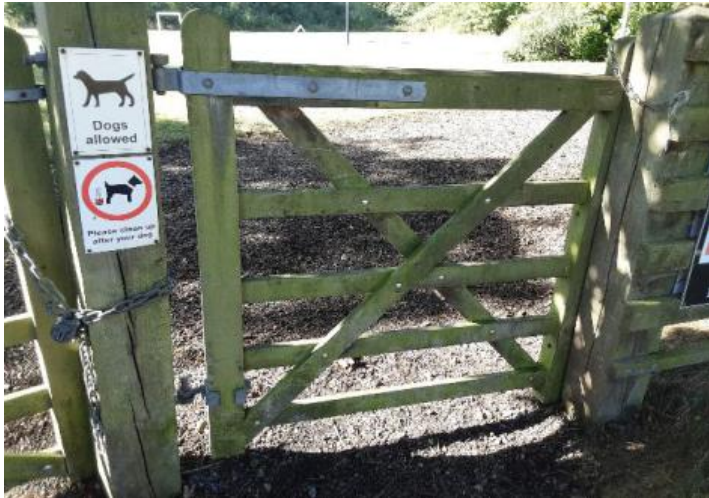
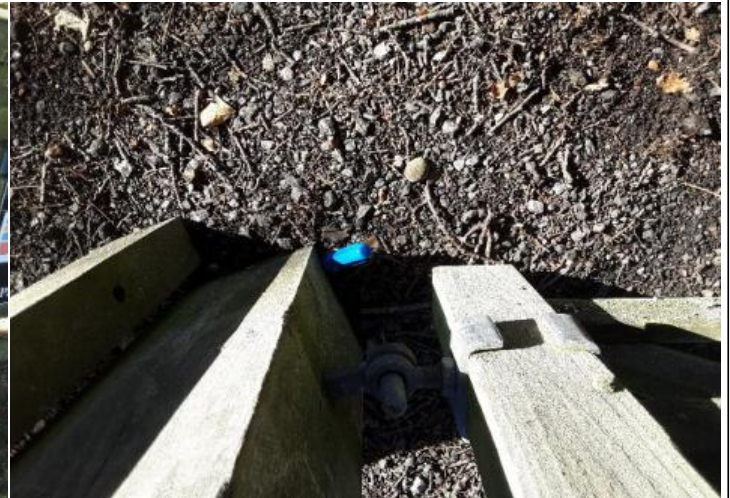
Finding: There are areas or parts of the timber hanging and slamming posts that have rotted
Action: Replace all affected timbers

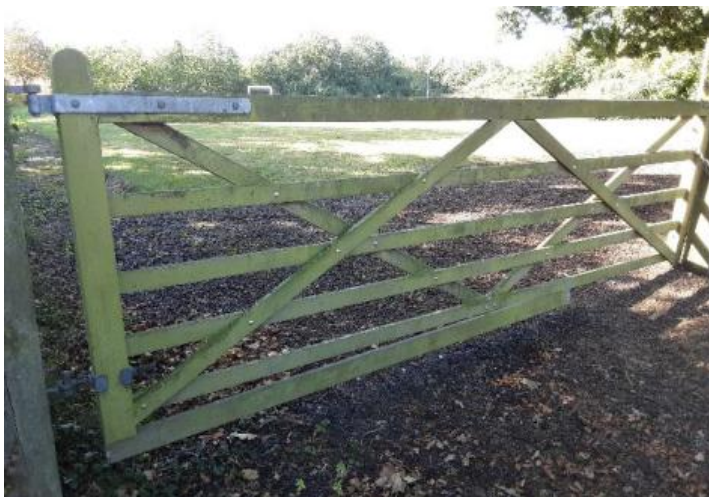
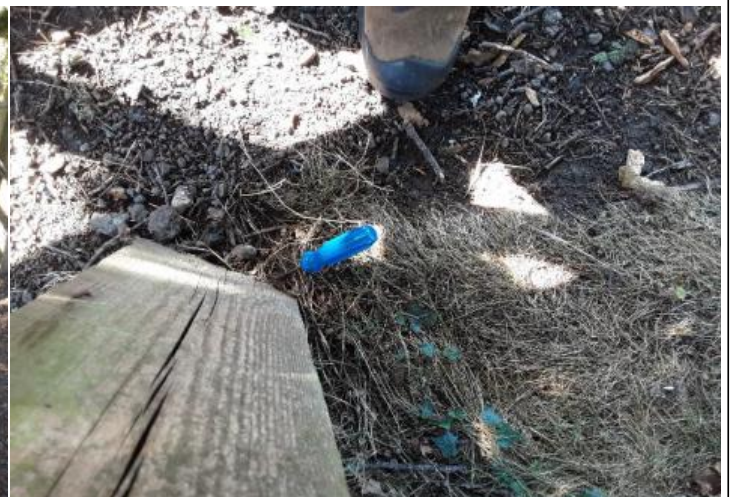
Finding: There are areas or parts of the timber hanging and slamming that have rotted
Action: Replace all affected timbers

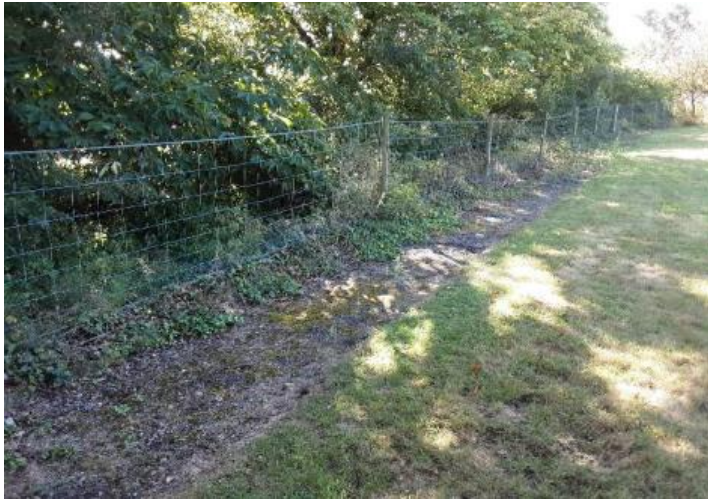
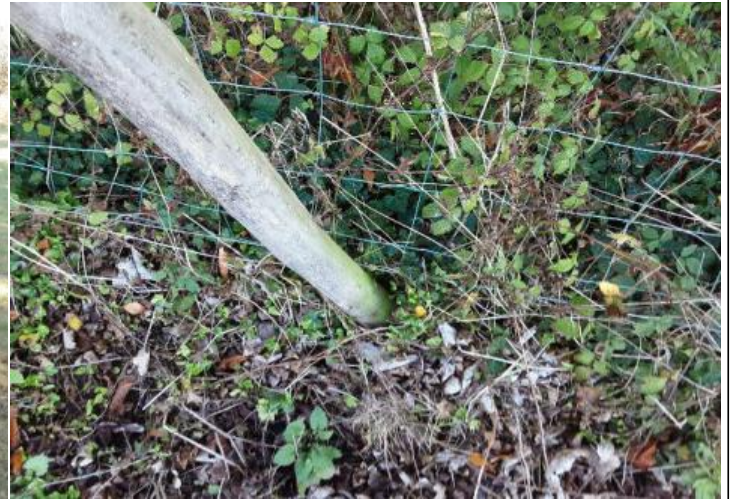
Finding: There are a number of loose posts around the fence

Action: Reset as required

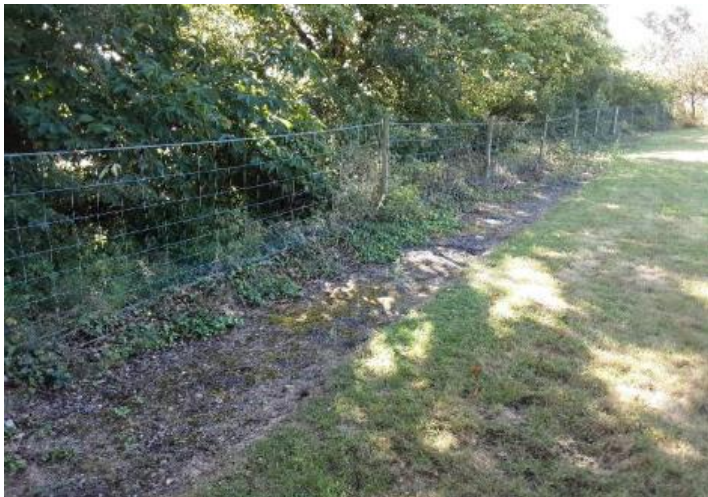
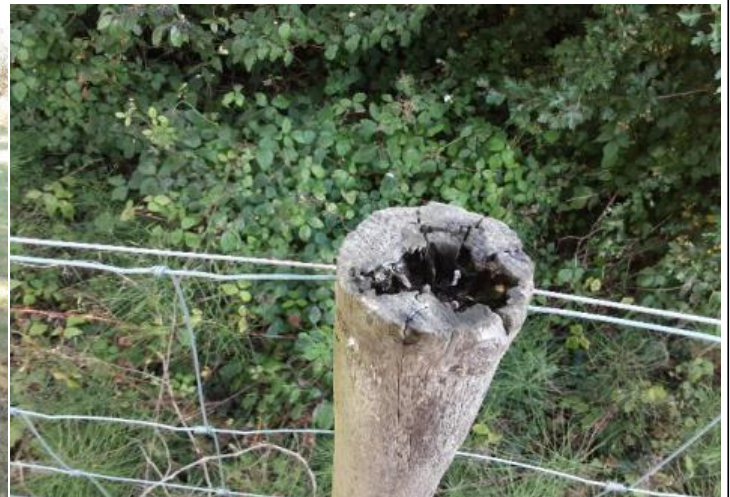
Finding: There are areas or parts of the timber on the structure that have rotted

Action: Replace all affected timbers

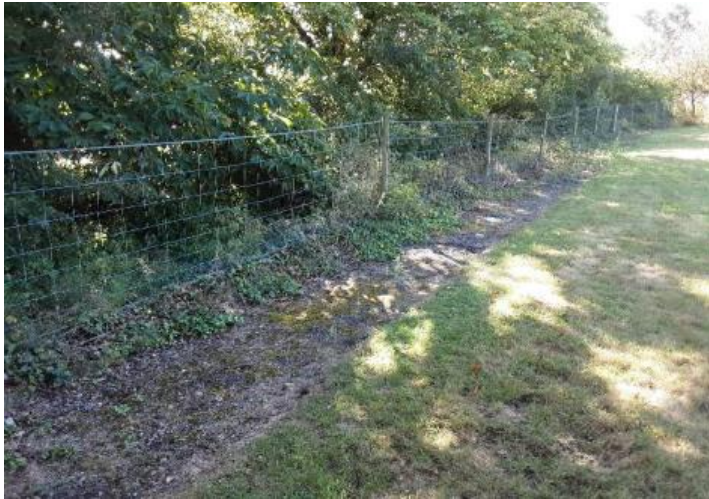
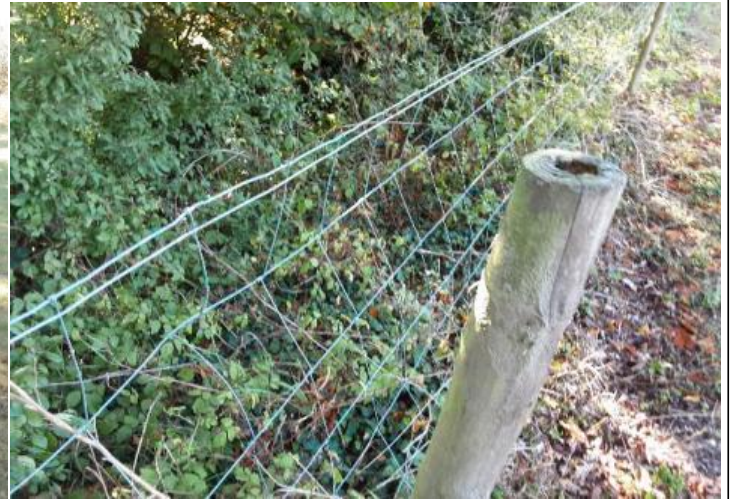
Finding: The fence is damaged in places

Action: Repair or replace all affected sections

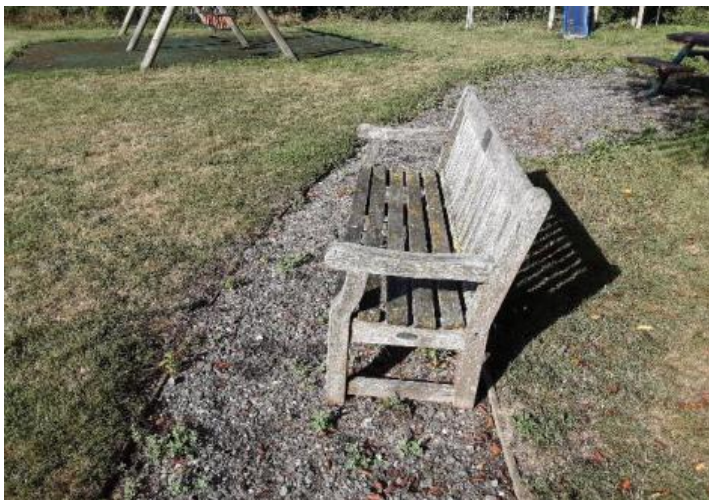
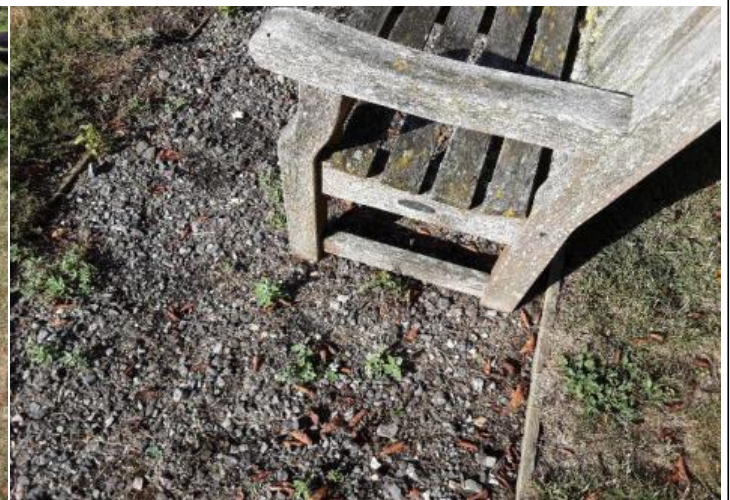
Finding: The bench is not securely fixed to the surface and there is some possibility of the item tipping or rolling over

Action: Secure the bench to the ground

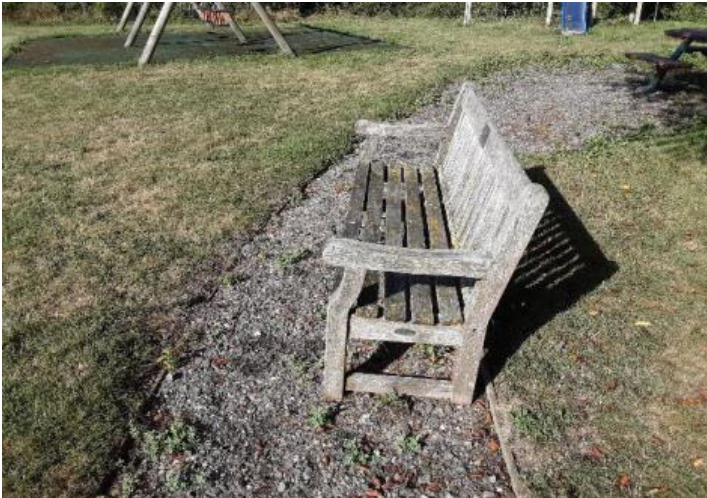
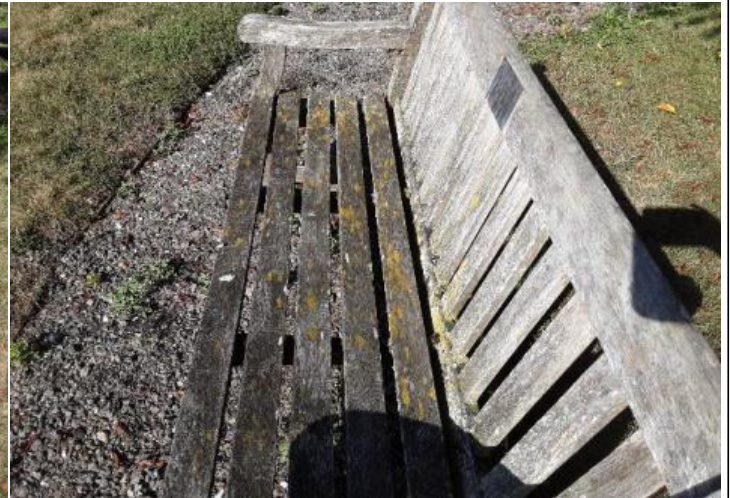
Finding: There is algae or moss on the bench

Action: Clean and treat appropriately

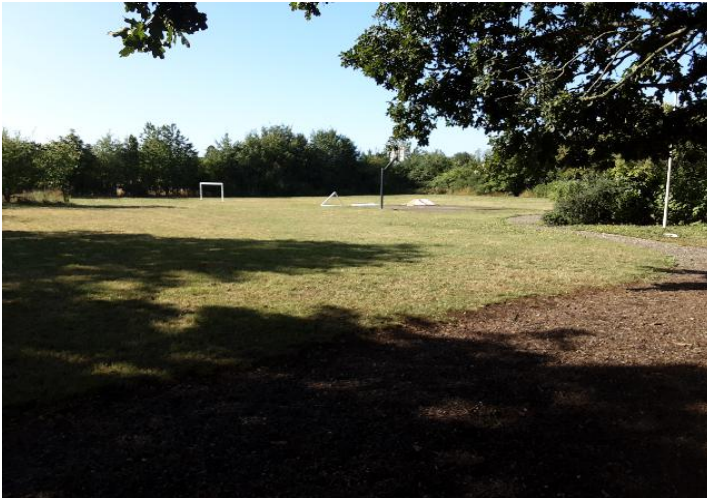
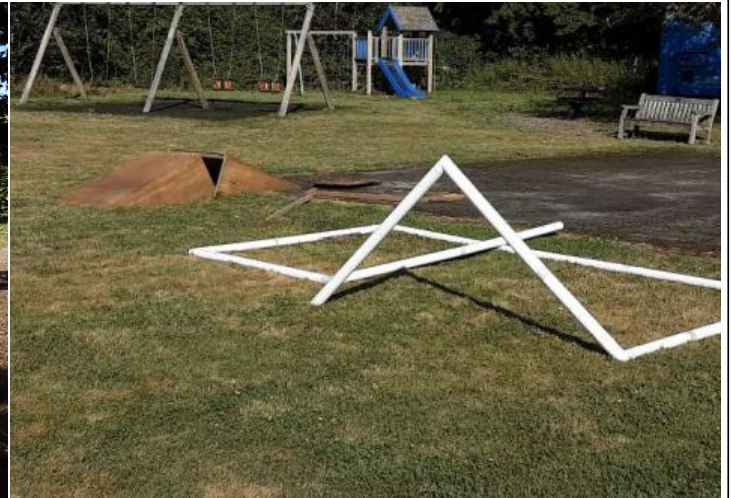
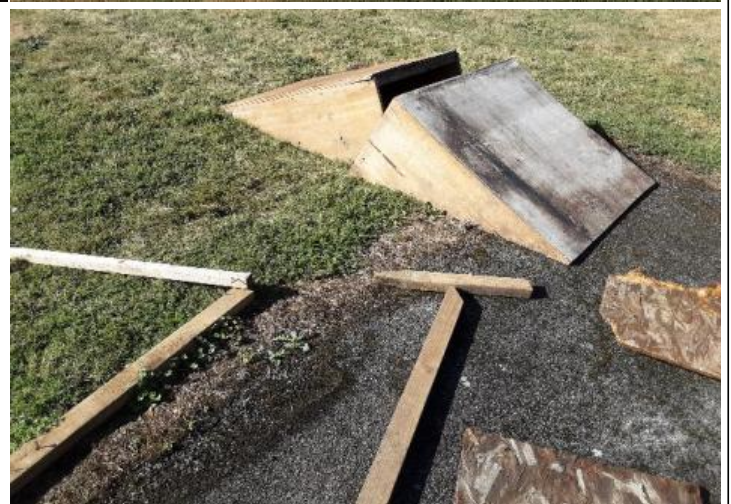
Finding: There are loose/damaged items in the play area

Action: Remove the loose/damaged items

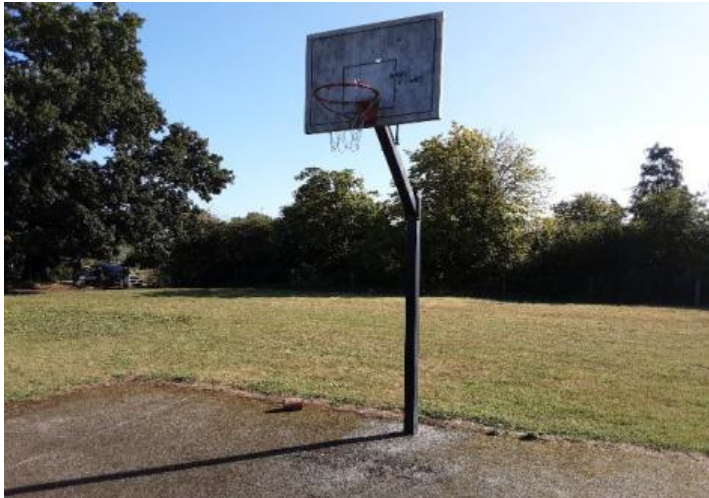
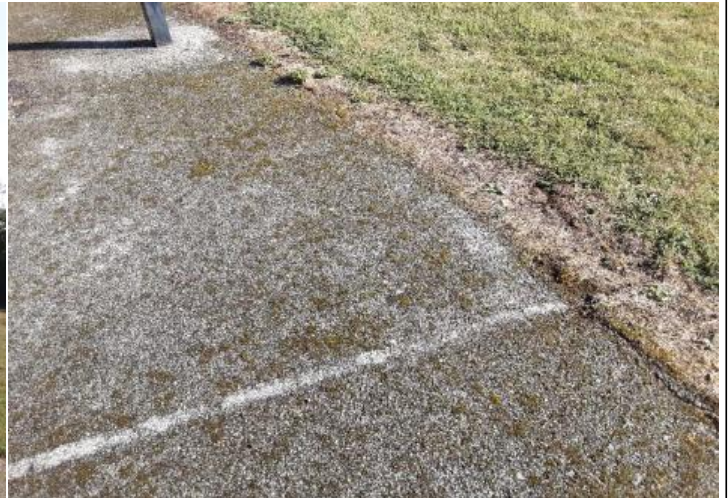
Finding: There is algae or moss growth on the tarmac surface resulting in slippery conditions

Action: Clean and treat appropriately

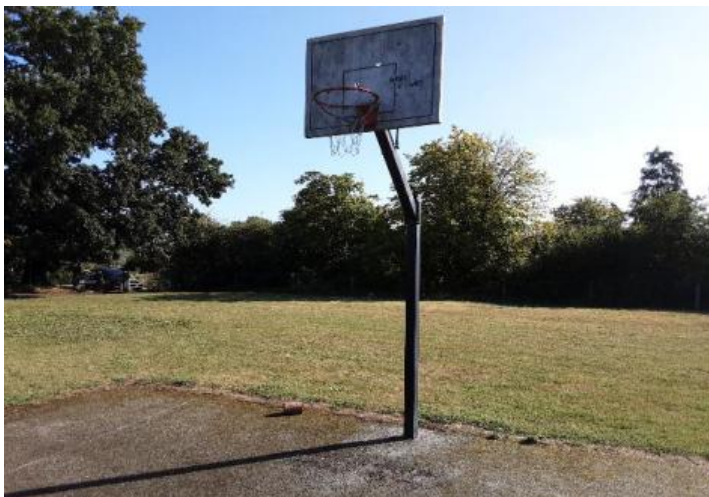
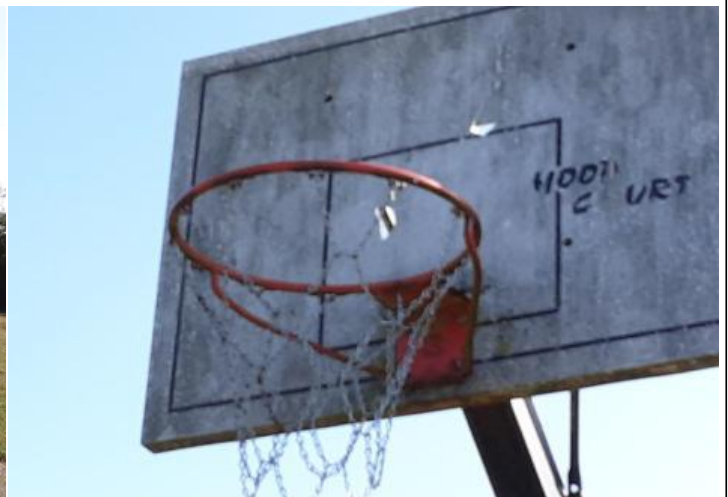
Finding: There is algae or moss on the surface of the equipment

Action: Clean and treat appropriately

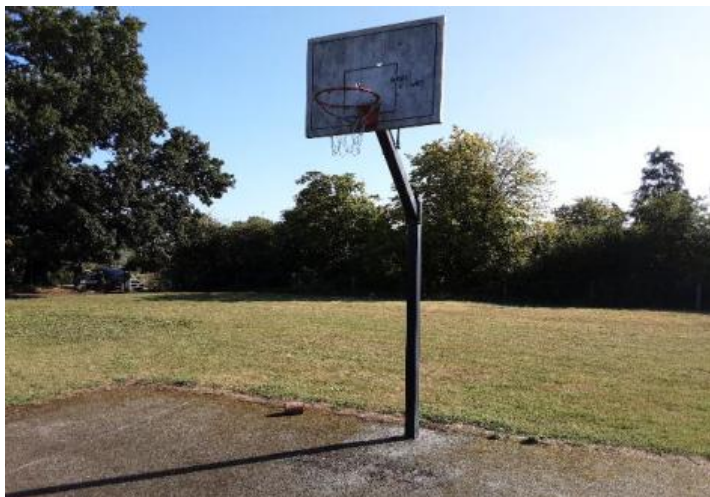
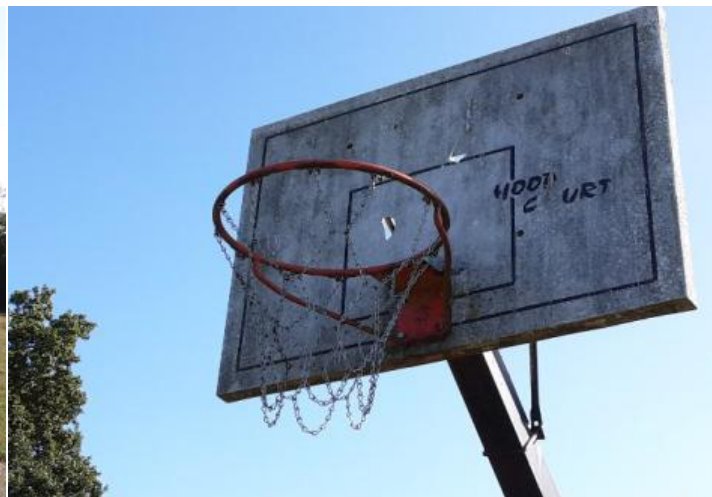
Finding: The backboard is damaged

Action: Monitor for any further deterioration and repair as required

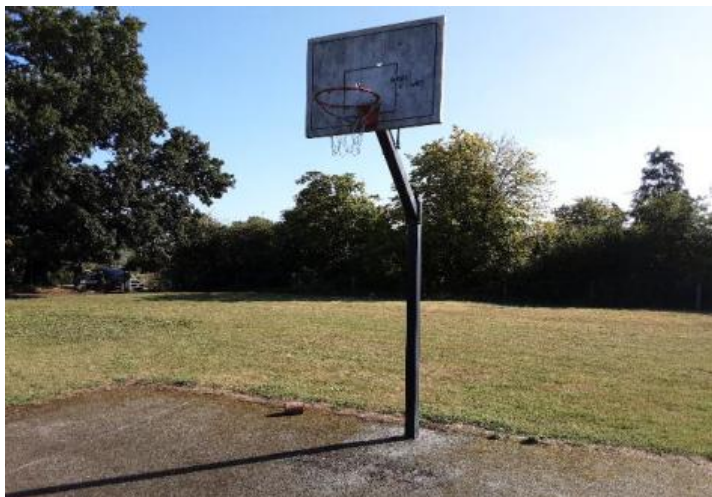
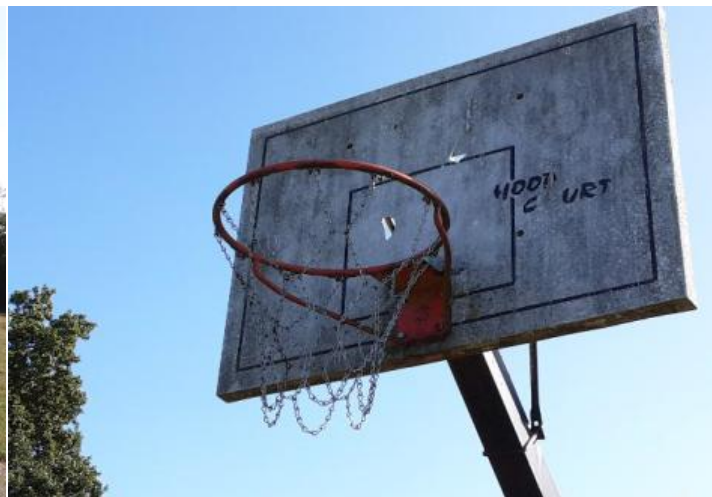
Finding: A clearly visible facility sign should be provided in a prominent position with the wording as detailed BS EN 15312- the equipment is not intended for children less than 3 years old- the warning - Do not climb on the framework or nets- the warning - Do not hang on the ring (if provided)- the warning - Do not wear rings or other jewellery- name and telephone number of the administrator- number to call in case of accident

Action: Monitor

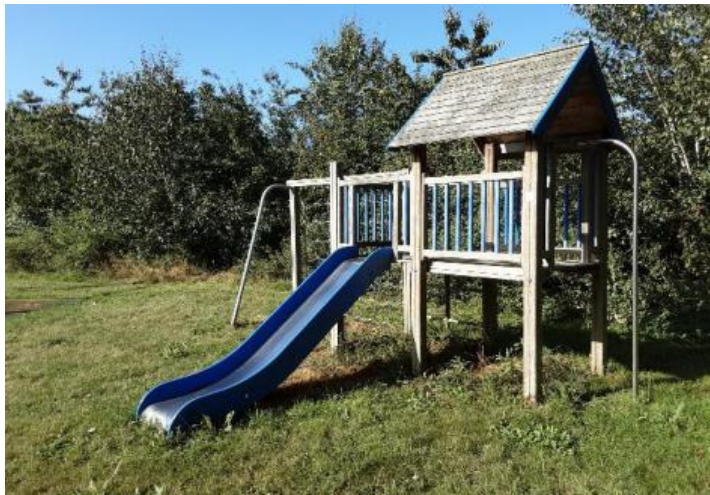
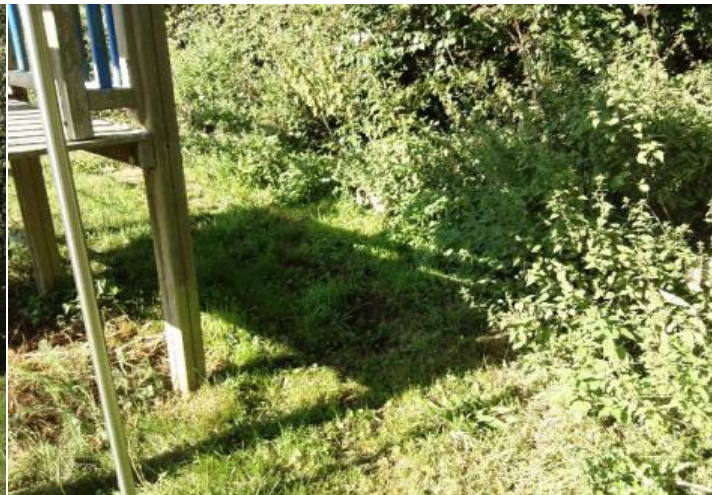
Finding: The hedge forms a hard object within the falling space of the equipment and there is also insufficient surfacing provided in contravention of BS EN 1176 Part 1

Action: Cut back the vegetation to provide a minimum of 1.50m unobstructed space

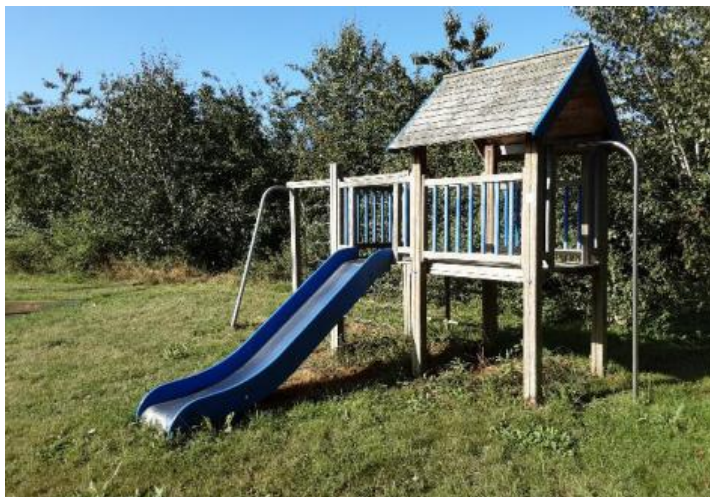
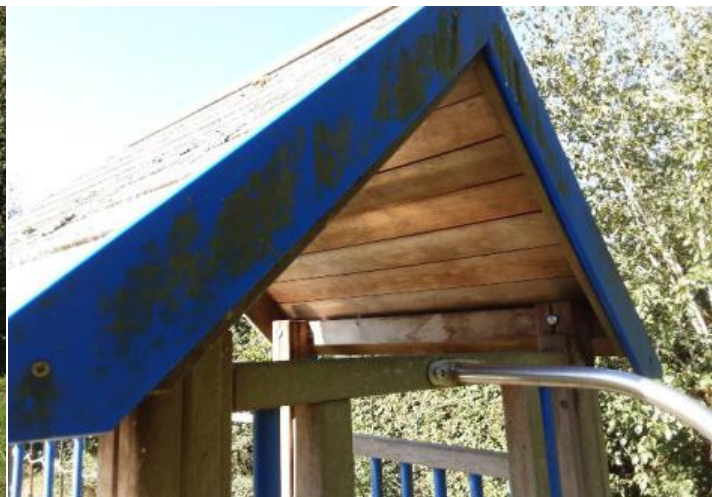
Finding: There is algae or moss on the surface of the equipment

Action: Clean and treat appropriately

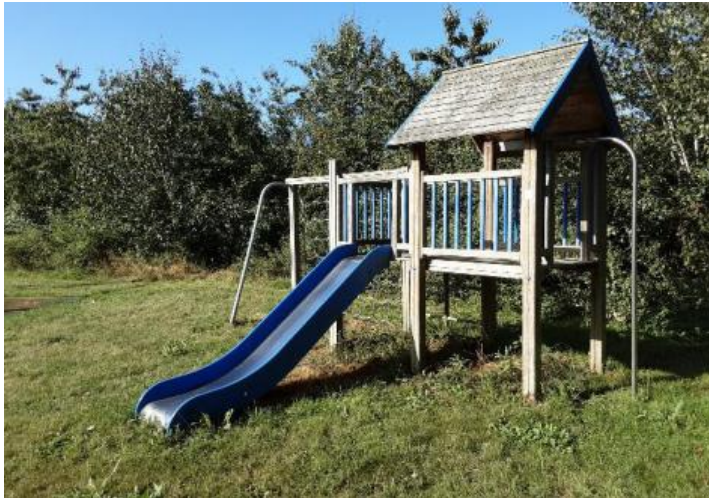
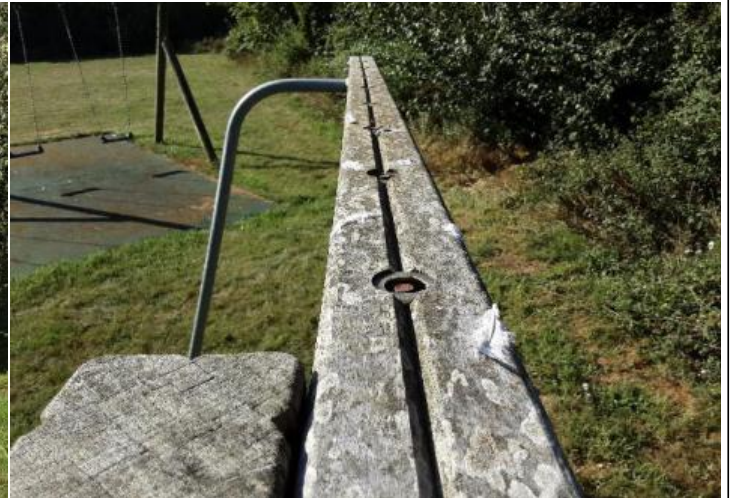
Finding: There is/are bolt cap covers missing or damaged on the item

Action: Replace missing or damaged bolt cap covers

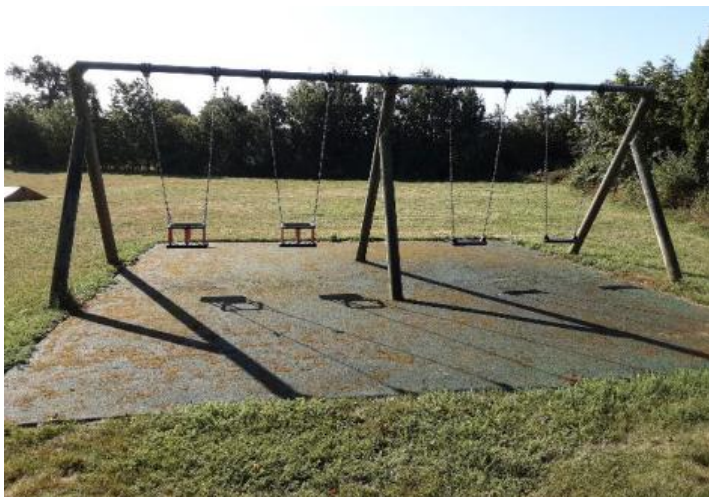
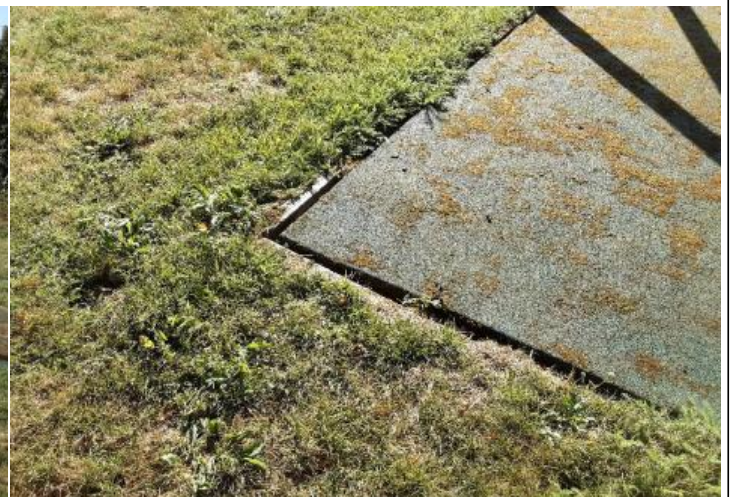
Finding: The surface is lifting at the edges and creating trip points

Action: Repair perimeter of surfacing to remove trip points

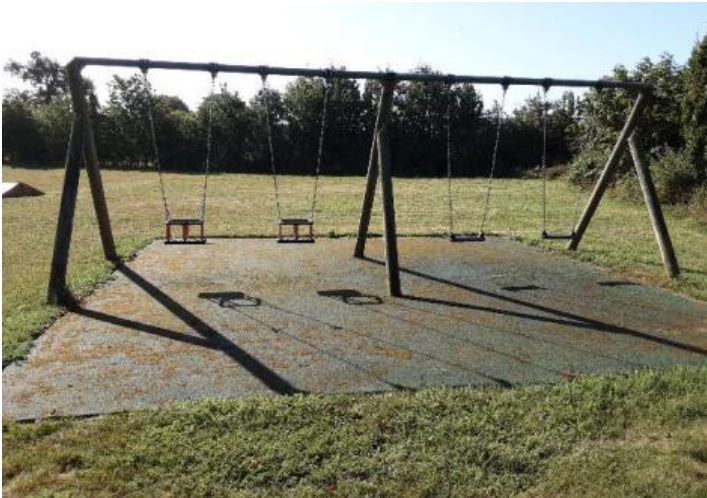
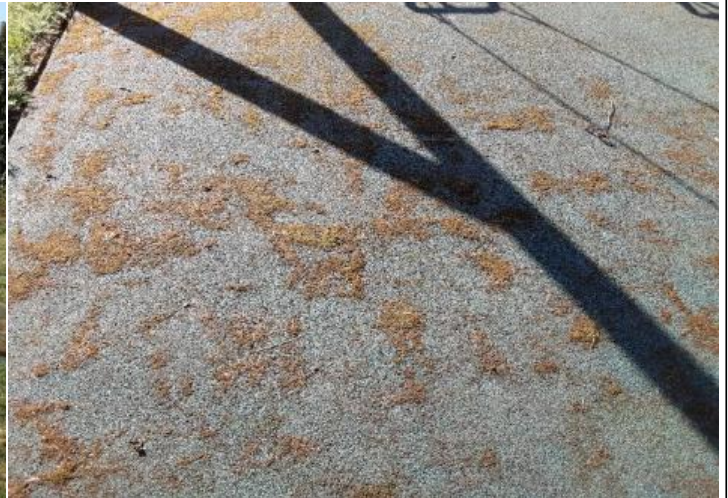
Finding: There is algae or moss growth on the wet pour surface resulting in slippery conditions

Action: Clean and treat appropriately

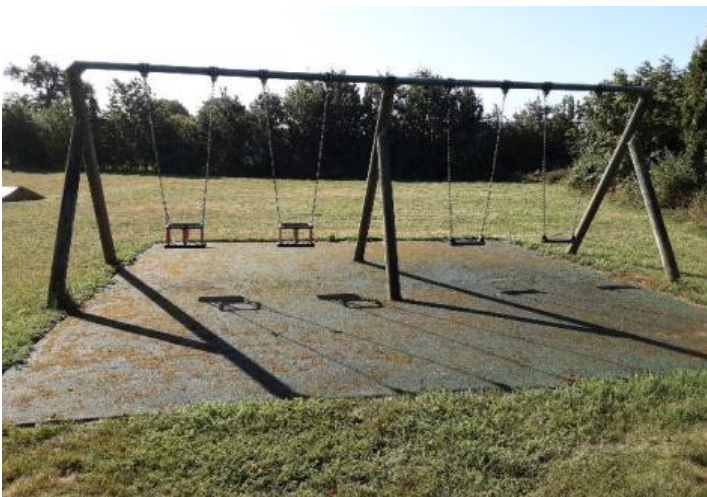
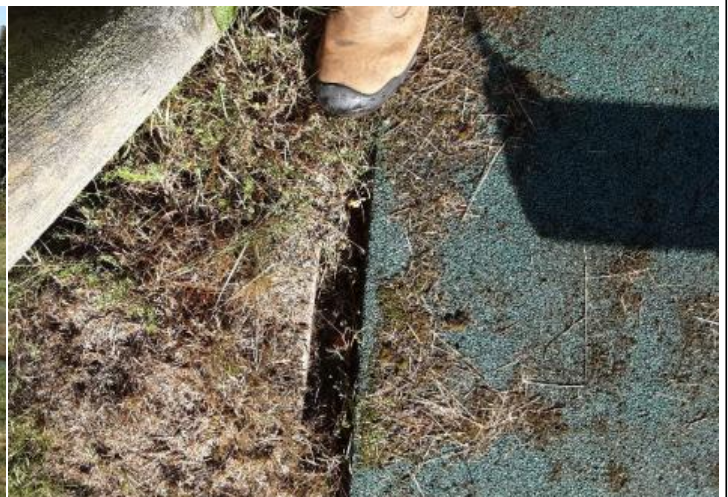
Finding: There are significant gaps (over 30mm) between the surface and the edging or between the joints in the surface; these are large enough for a small foot to enter

Action: Repair surfacing

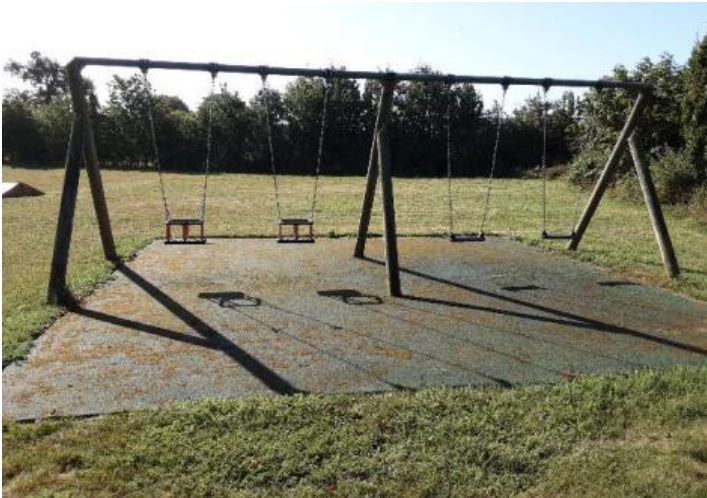
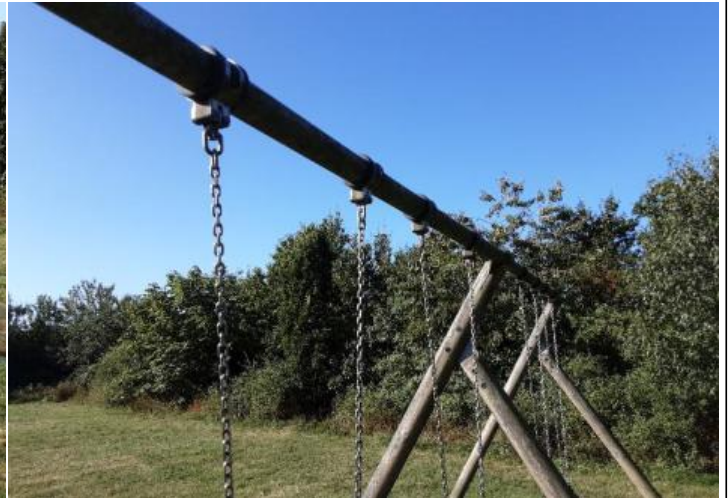
Finding: The bushes are showing signs of wear

Action: Monitor for any further deterioration and replace as required

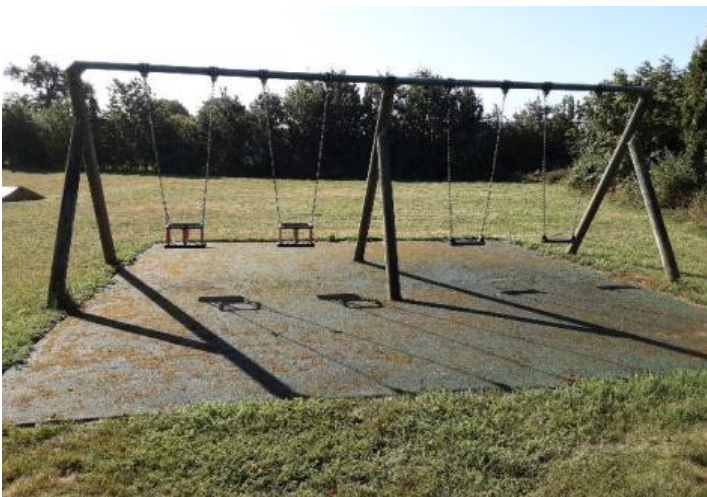
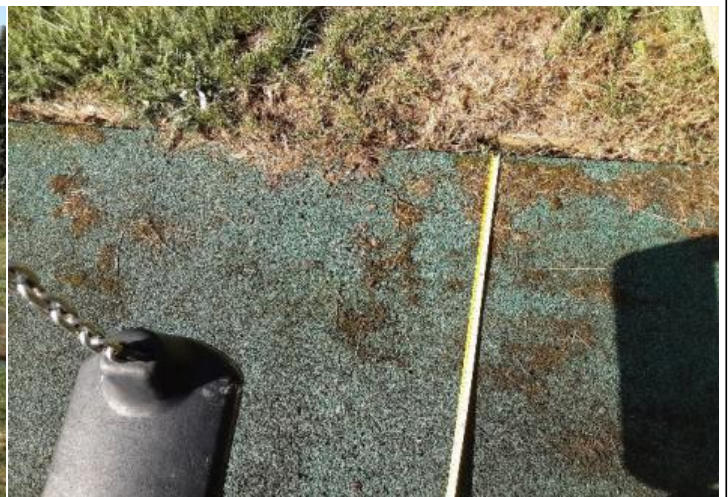
Finding: The surfacing width under each seat is less than 1.75 metres and fails the requirements of BS EN 1176 Part 2

Action: Monitor - No remedial work recommended

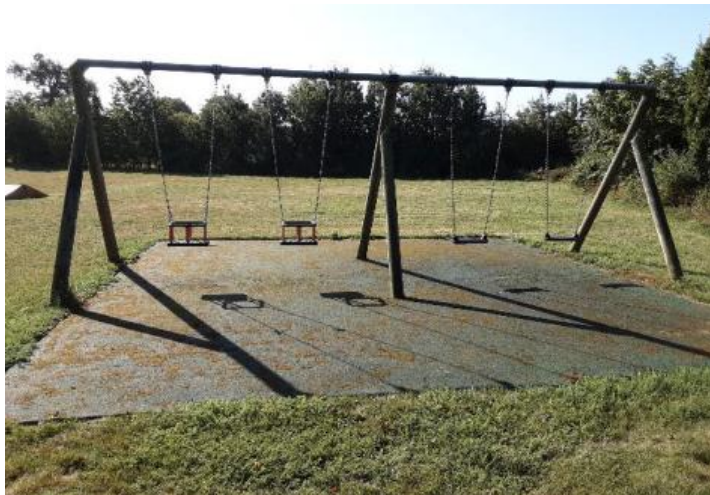
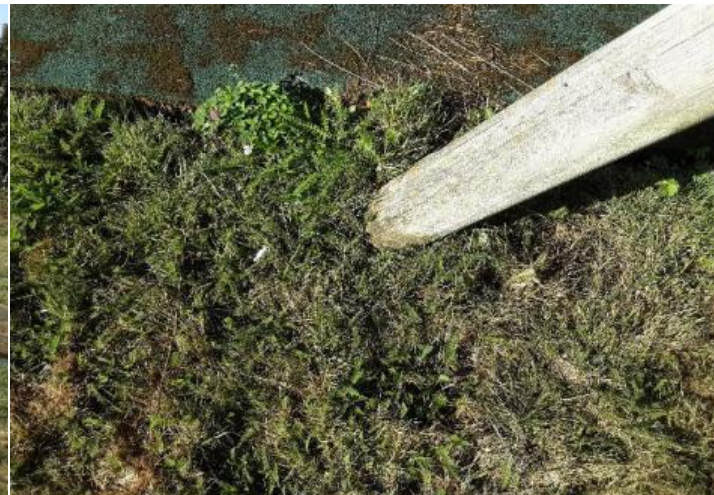
Finding: There is some strimmer / machinery damage apparent on the posts, this can penetrate the preservative applied to the timber and accelerate the rotting process

Action: Monitor for any deterioration (rot) and replace as required

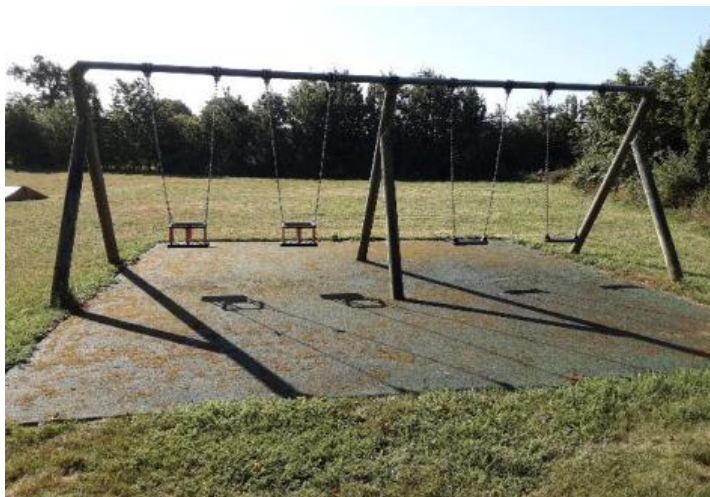
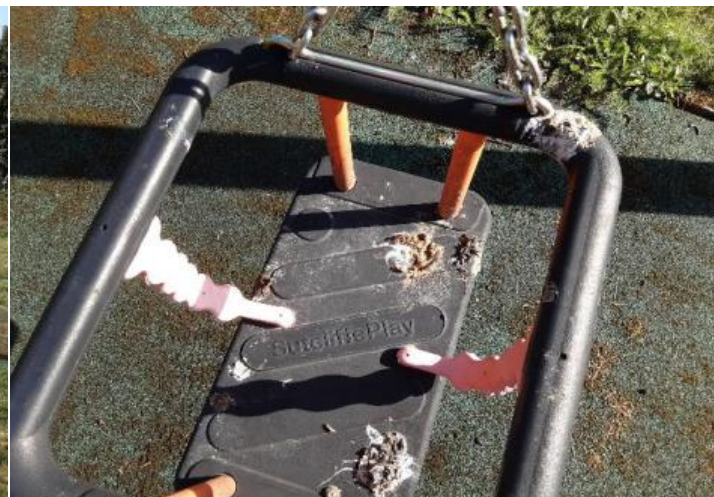
Finding: There is excrement on the seat

Action: Clean and maintain the seat
