Historic England

# Redlingfield Hall, Eye, Suffolk

## Analytical earthwork survey

Research Report Series 066-2017

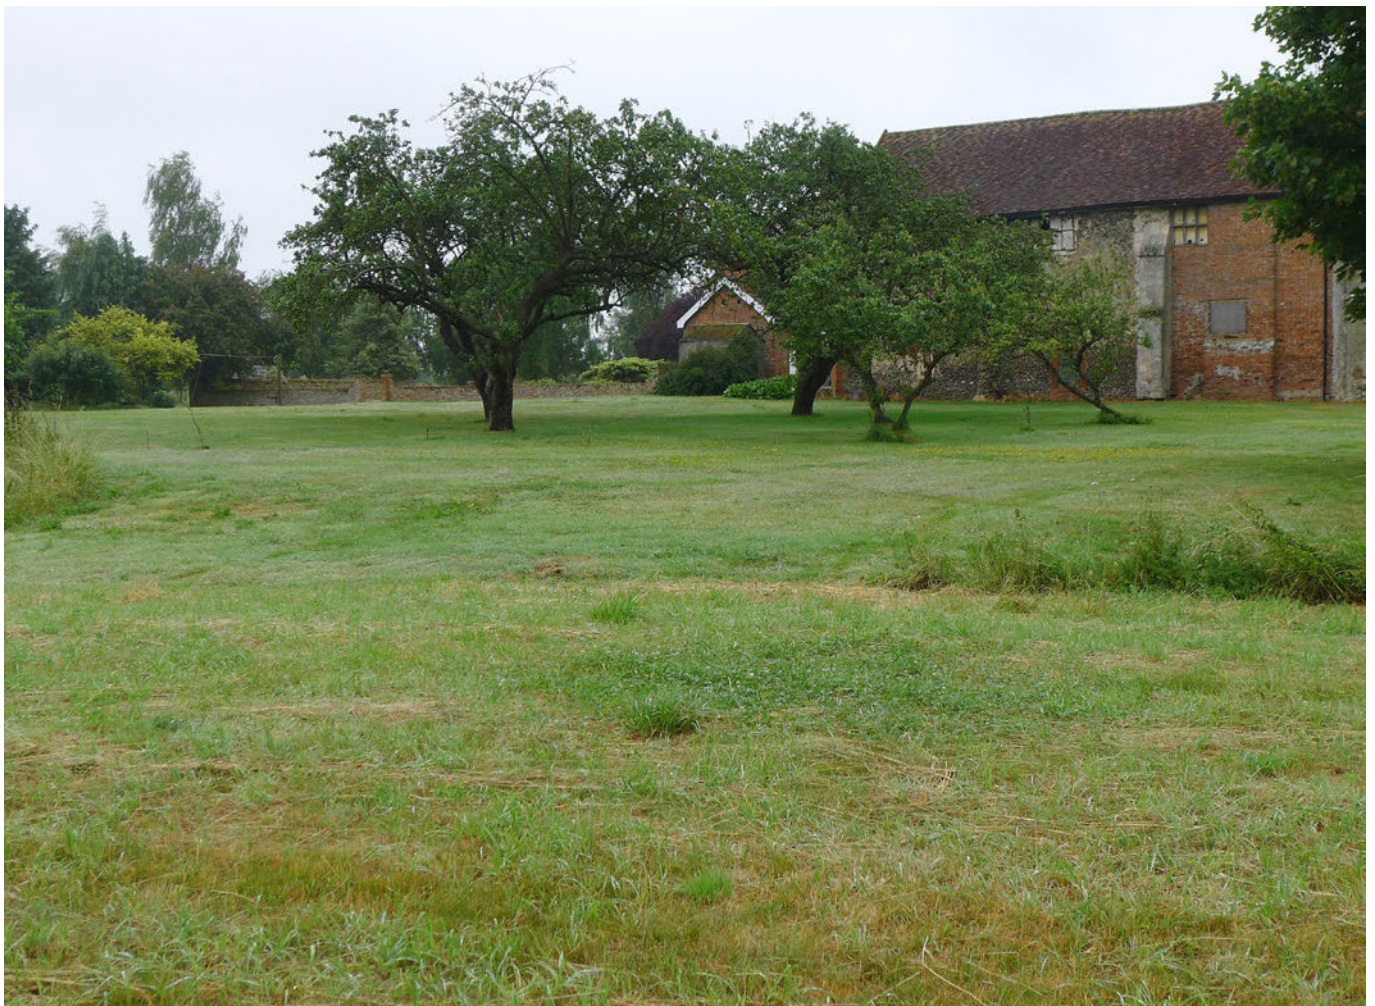
The north-east of the site looking south-west viewed from the valley floor. The rise in the foreground may mark the eastern extent of the priory precinct, the trees beyond are probably in the area of the priory cloister. The listed barn, probably based upon the western monastic range can be seen beyond (Magnus Alexander © Historic England)

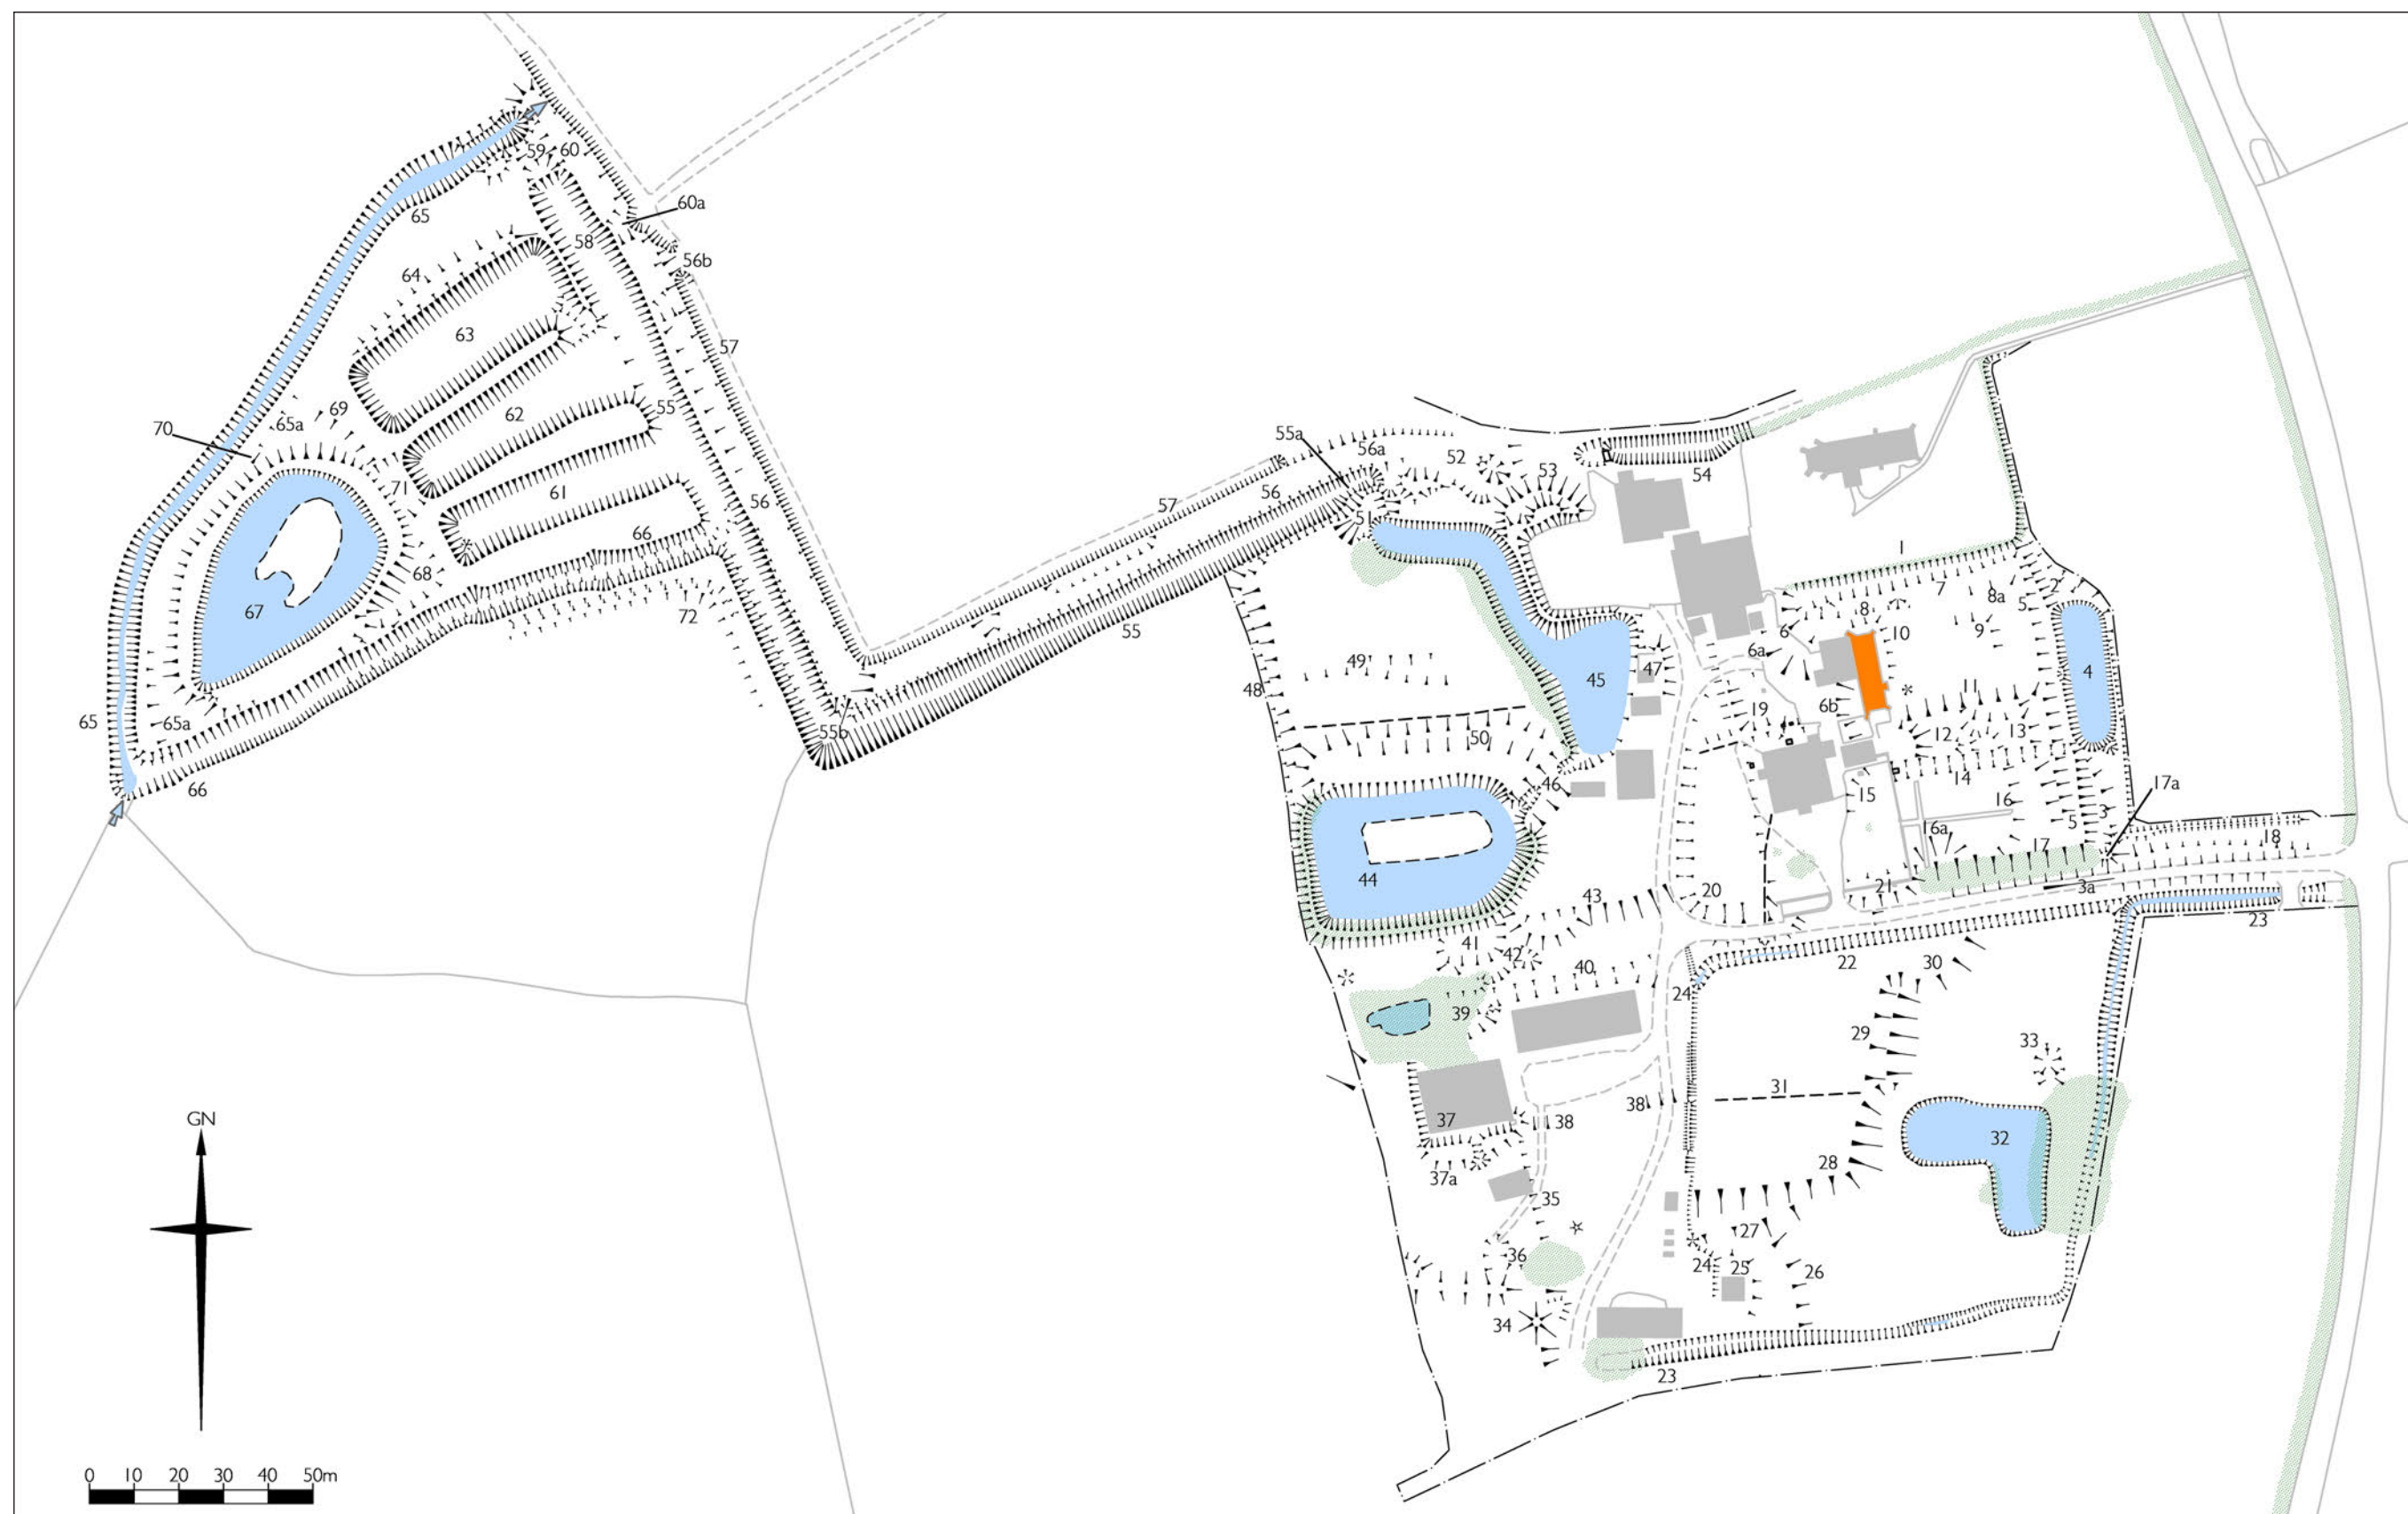
Figure 4 –Earthworks around Redlingfield Hall and The Leys based on a survey undertaken January 2017, 1:1500 at A3, note that the pond complex and channel linking this area with the farm was heavily vegetated – this has not been shown for clarity (© Historic England, Modern Ordnance Survey mapping: © Crown Copyright and database right 2017. All rights reserved. Ordnance Survey Licence number 100024900.)
