Annual Inspection

Mid Suffolk District Council

Redlingfield Play Area

Inspection Ref: 1169217

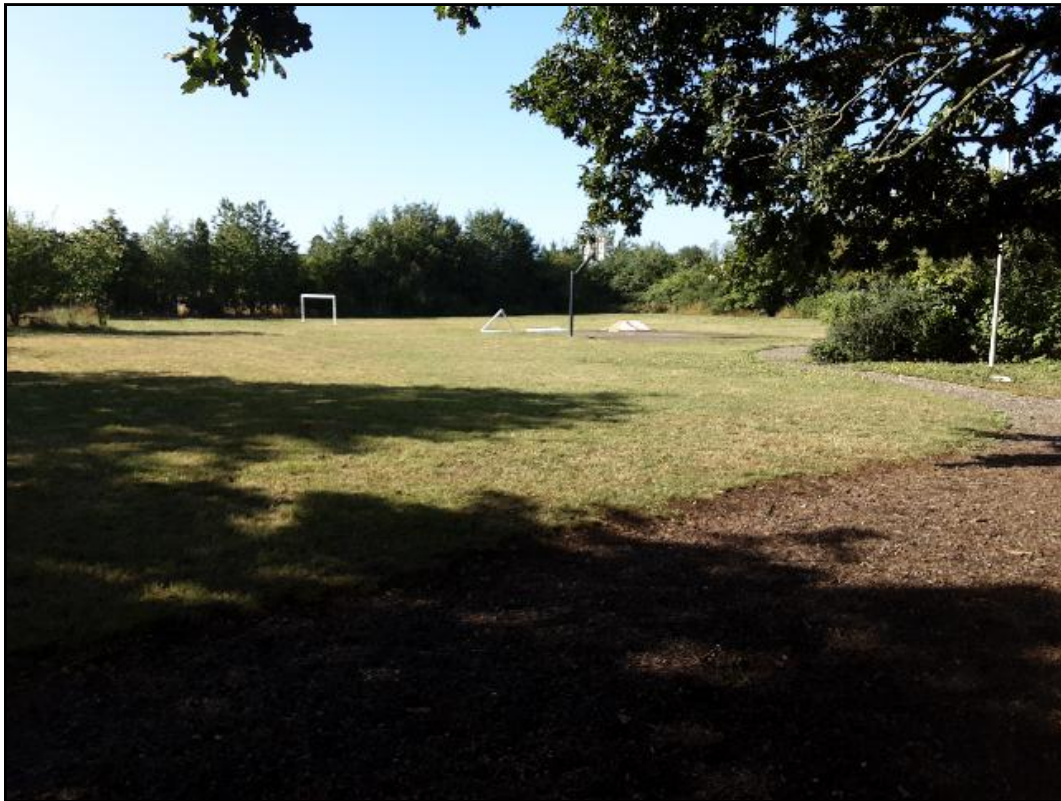
Location:

The site is located in an area of public open space and is not directly overlooked by any properties in the local community.

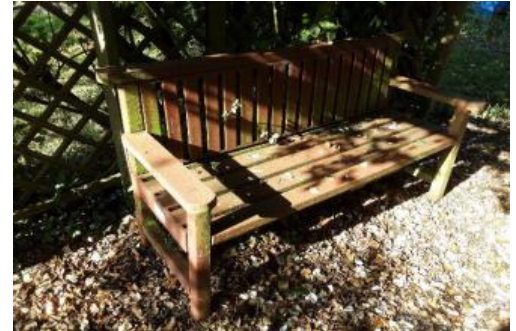
Item: Bench
Manufacturer: Not Identified
Surface Type: Compacted Stone
Item Quantity: 2
Equipment Compliance: N/A
Surface Area Compliance: N/A

Finding 1

This item is satisfactory - no work required -

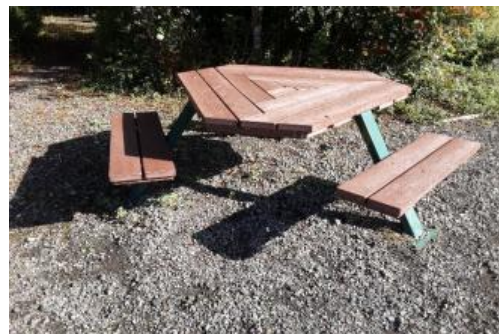
Item: Picnic Table
Manufacturer: Not Identified
Surface Type: Compacted Stone
Item Quantity: 2
Equipment Compliance: N/A
Surface Area Compliance: N/A

Finding 1

This item is satisfactory - no work required -
